High Voltage Electrical Substations:

Infrastructure Renewal and Sustainable Design

Southlake Regional Health Centre undertakes an equipment replacement project in their High Voltage Electrical Substation, while remaining fully operational.

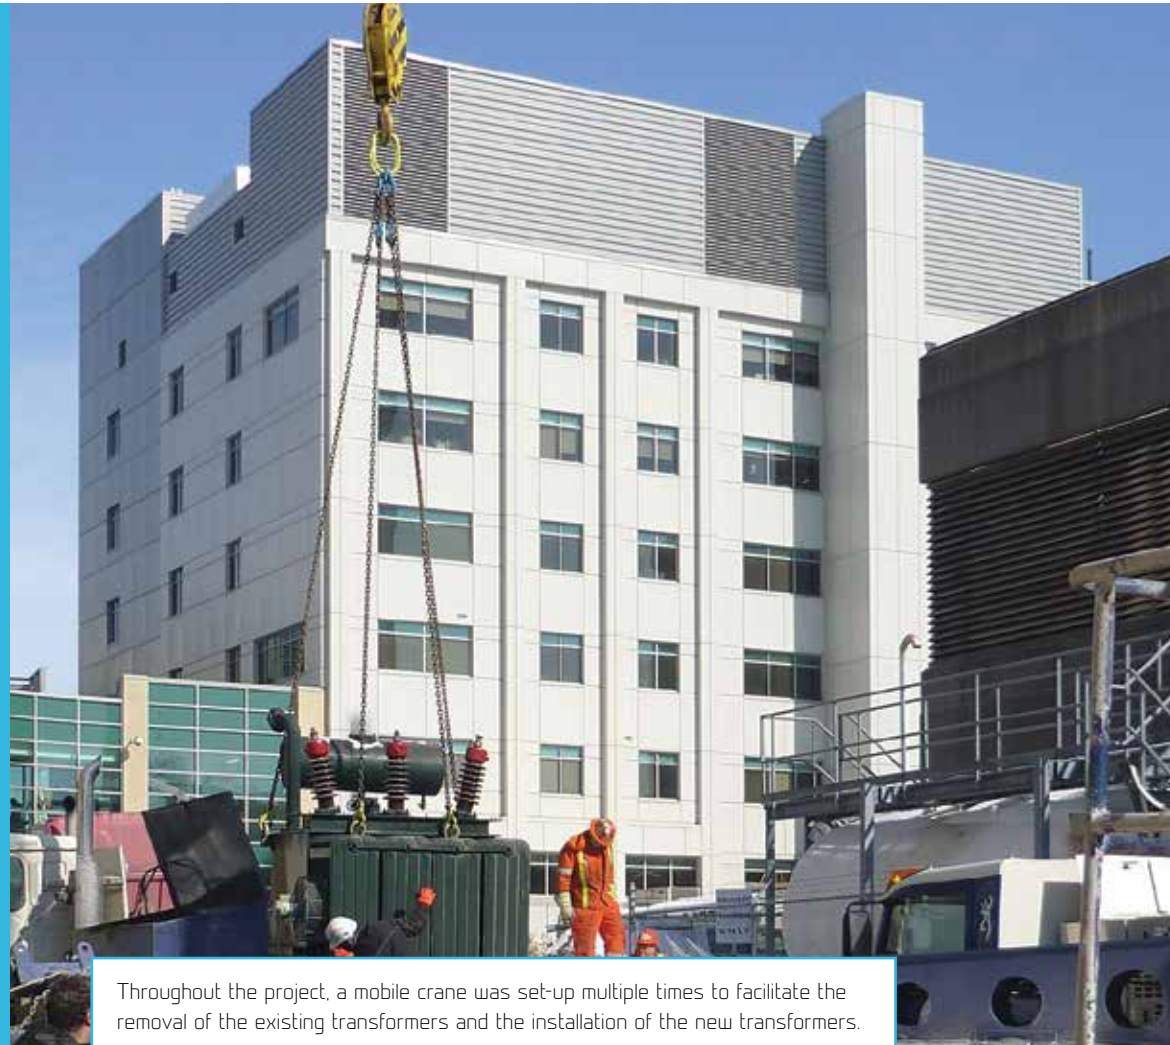
Throughout the project, a mobile crane was set-up multiple times to facilitate the removal of the existing transformers and the installation of the new transformers.

The delivery of the transformers was determined in advance of their arrival and the contractor worked on preparing the site to receive the new transformers. Site preparations included: the excavation and removal of the existing transformer base; installing a new cast in place, reinforced concrete base; and modifying the 600/347V switchboard for the new secondary connections. The mobile crane was set up and the first of replacement transformers was lifted into place. Following the installation of the transformer, the replacement primary throat connection was installed and the 44,000V bus connections were extended to the transformer's high voltage bushings. A secondary cable bus system was installed from the low voltage bushings to the main 600/347V distribution switchboard in the central plant. The installation was commissioned, inspected and tested, before the newly installed transformer was energized. The ability to successfully carry load was determined and entire campus load was subsequently swung over to the newly installed

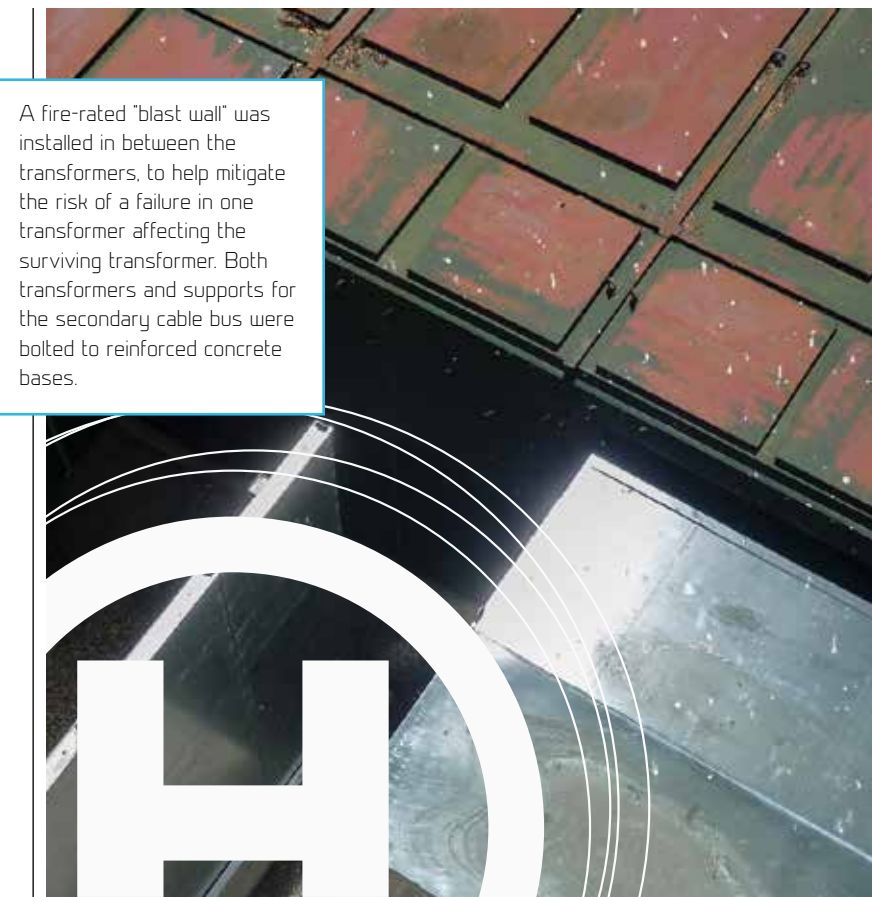
A fire-rated "blast wall" was installed in between the transformers, to help mitigate the risk of a failure in one transformer affecting the surviving transformer. Both transformers and supports for the secondary cable bus were bolted to reinforced concrete bases.

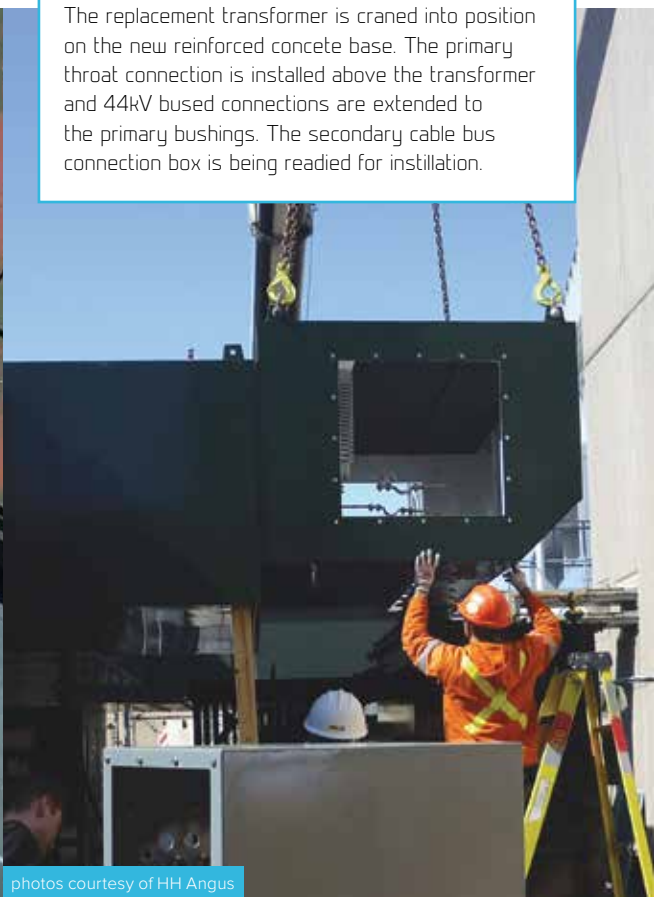
The replacement transformer is craned into position on the new reinforced concrete base. The primary throat connection is installed above the transformer and 44kV bused connections are extended to the primary bushings. The secondary cable bus connection box is being readied for installation.
